Manhole Inspection Summary

Manhole # S53O__047MH

Insp Date: **4/17/08 8:07 AM**

Location Address: **3101 south ellwood avenue**

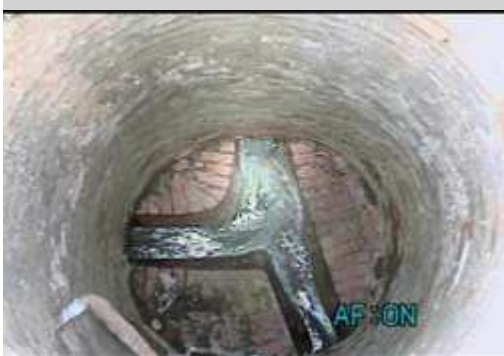
Defect

Missing: **1**

☒ **Corroded**

1 missing step & Corroded Steps

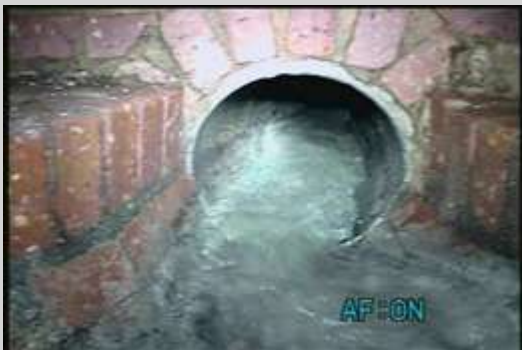
12 O'Clock Outflow

8 in. Circular Gravity Sewer
Pipe Out @ 12 O'Clock

Pipe Material: **Clay** ☐ Pipe Lined

Invert Depth: **9.20** (ft.) Flow Characteristics: **Fast**

Deposits: ☒ None ☐ Mud ☐ Sludge ☐ Debris ☐ Grease

Infiltration: **None** Pipe Seal Cond: **Unknown**

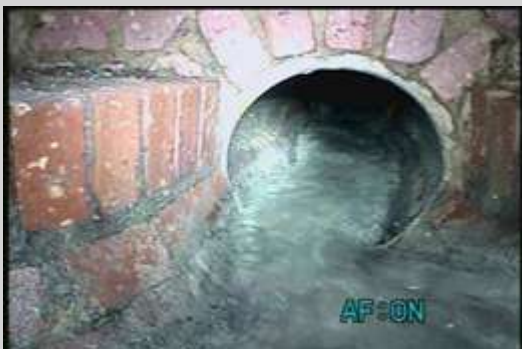
6 O'Clock Inflow

8 in. Circular Gravity Sewer
Pipe In @ 6 O'Clock

Pipe Material: **Clay** ☐ Pipe Lined

Invert Depth: **9.00** (ft.) Flow Characteristics: **Fast**

Deposits: ☒ None ☐ Mud ☐ Sludge ☐ Debris ☐ Grease

Infiltration: **None** Pipe Seal Cond: **Unknown**

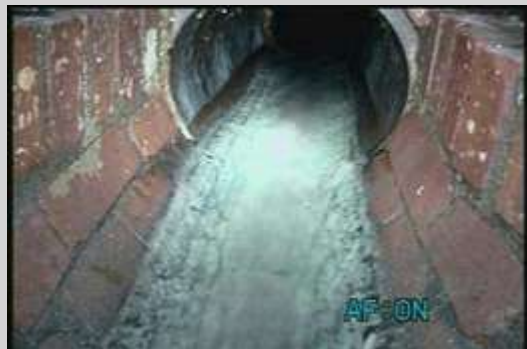
9 O'Clock Inflow

8 in. Circular Gravity Sewer
Pipe In @ 9 O'Clock

Pipe Material: **Clay** ☐ Pipe Lined

Invert Depth: **9.00** (ft.) Flow Characteristics: **Fast**

Deposits: ☒ None ☐ Mud ☐ Sludge ☐ Debris ☐ Grease

Infiltration: **None** Pipe Seal Cond: **Unknown**
